# LIDAR 2003 Quality Assurance Report

Authored by Dewberry LLC  
2003

## Introduction

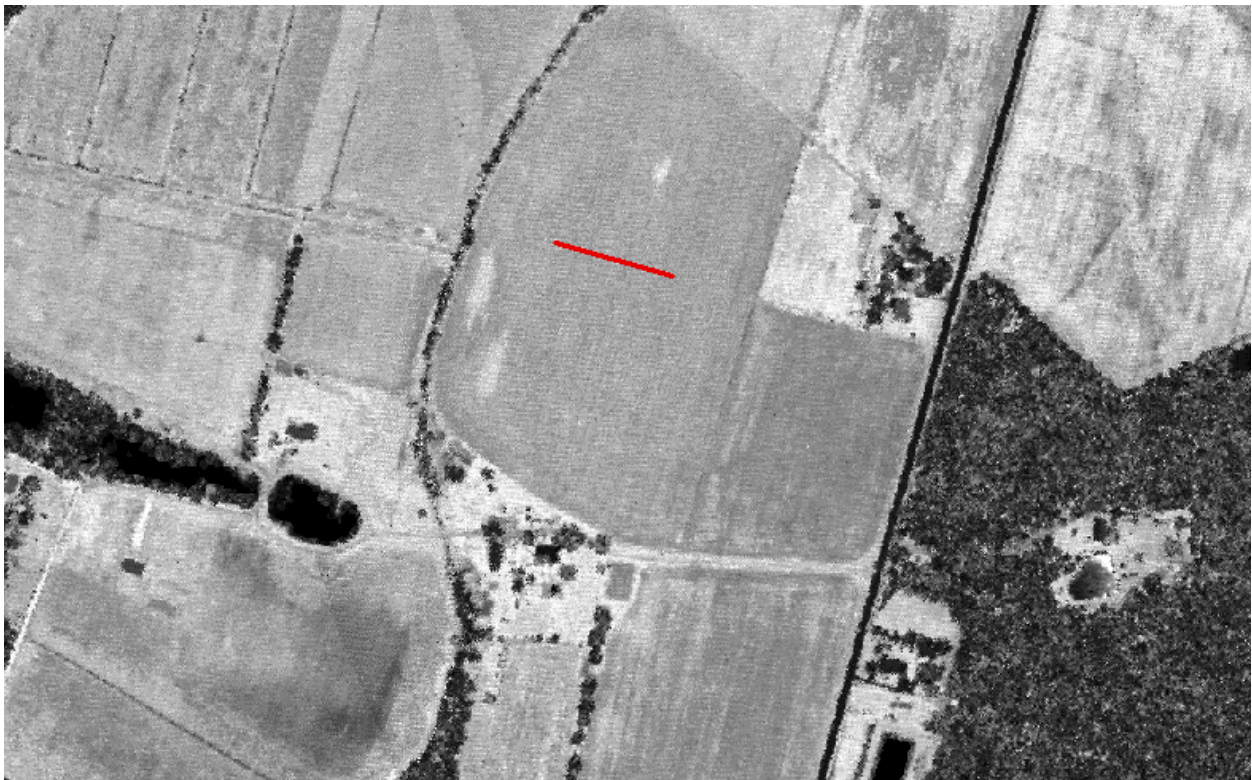
**Figure 10 – Location of cross section in middle of agricultural fallow field using the intensity image.**

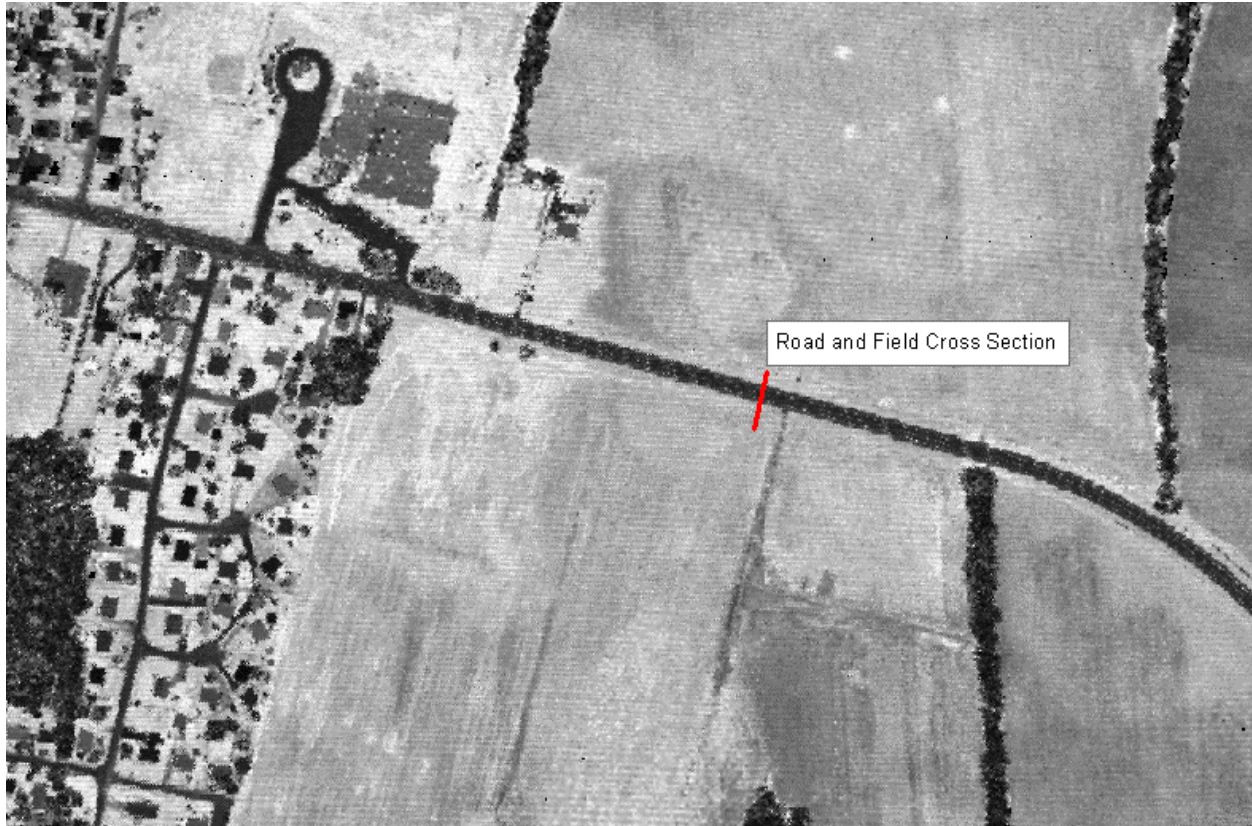
Figure 18 and Figure 19 illustrate the location and related cross section encompassing the field drainage ditch and road. The road is elevated from the fields which is typical.

Figure 18 – Location of cross section of road and drainage ditches.

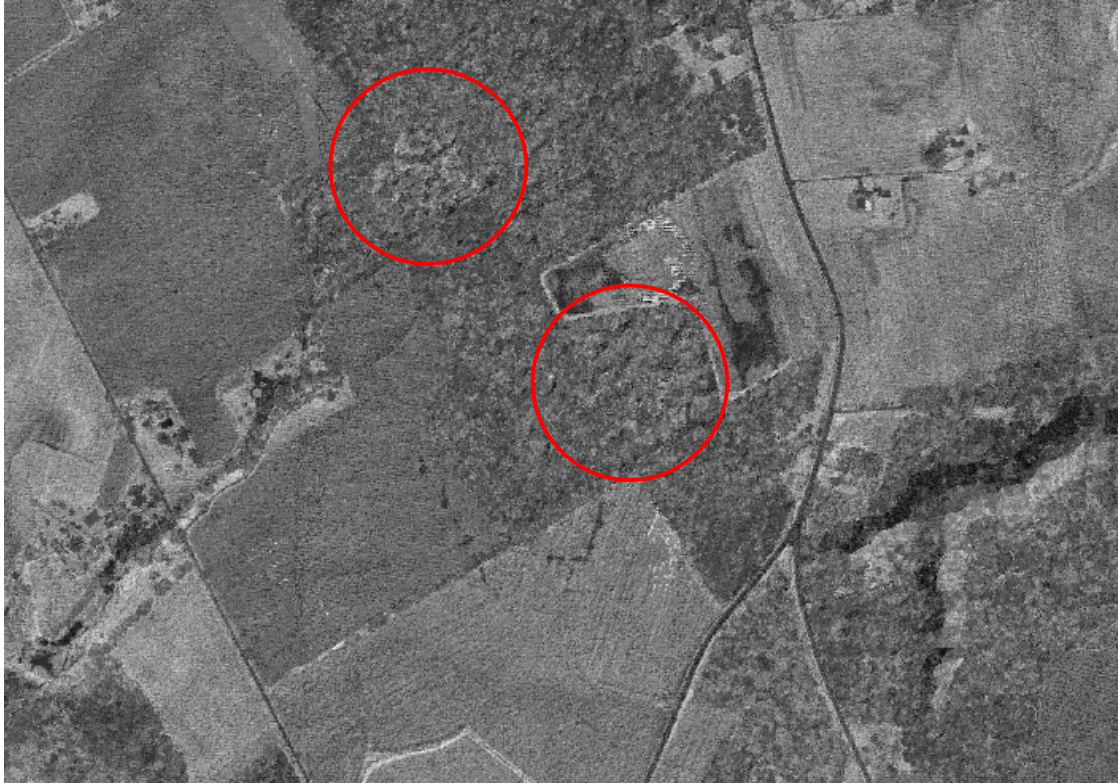
Figure 22 and Figure 23 illustrate potential artifacts. The TIN triangles in these areas are larger because elevated points were filtered out and there are fewer remaining LIDAR points that penetrated the dense vegetation to the forest floor in these areas.

**Figure 23 – Areas of potential artifacts located within forested area.**

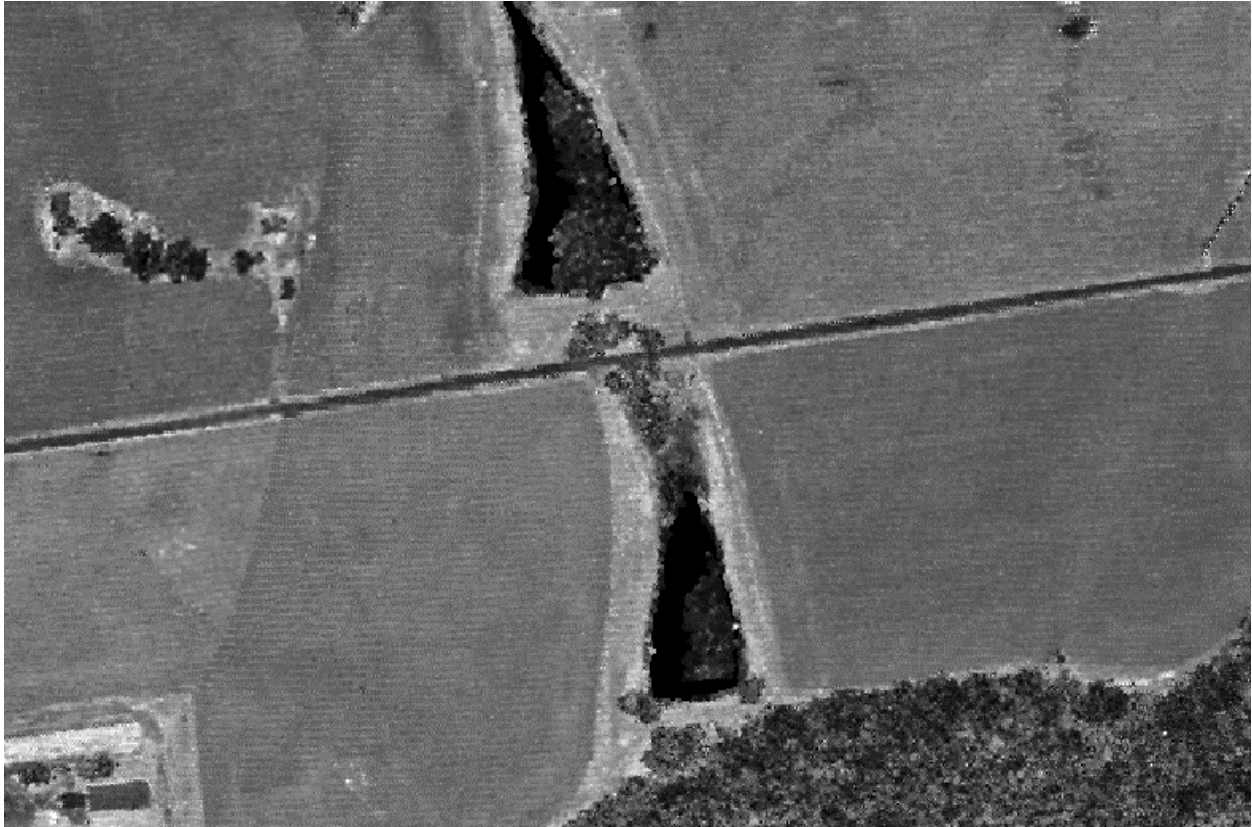
**Figure 26 – Intensity image of culverts and "land bridge" or dam. Notice the topography north of the road based on the intensity image and that of the correlating elevations from Figure 25.**

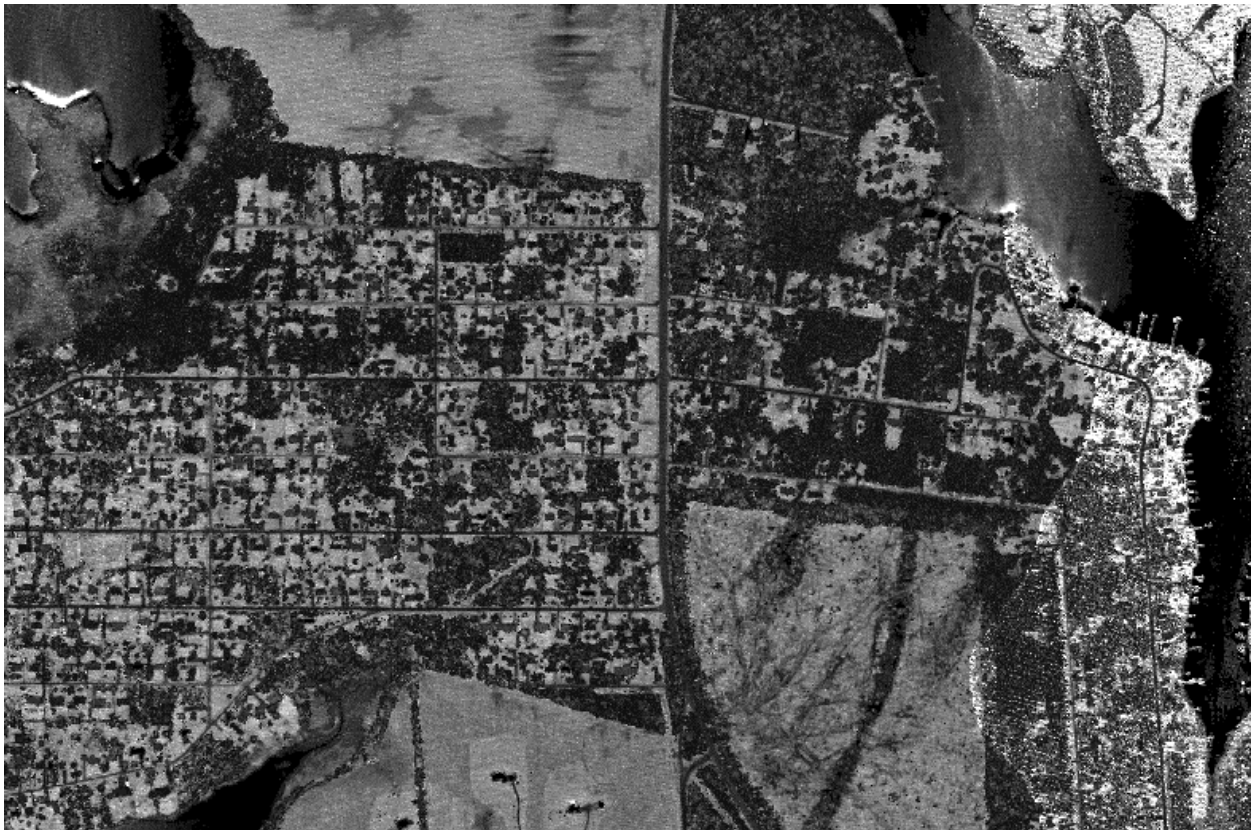
utilizing this texture, we are able to ascertain some of the land cover categories and the level of confidence we have in their corresponding elevations. Currently the industry is researching ways to utilize these images to their full potential, but at this time there are not definitive tool sets to accomplish this automatically. Corrections are needed to normalize images between flight lines and between images, to apply radiometric corrections, and to perform tonal balance. The users must be aware that this is not a true photographic image and is not meant to replicate photography but that it is an excellent source of information to use in conjunction with the elevation data. Figure 29 illustrates the original intensity image which is dark and hard to see. Also two different flight lines can be seen on the right side of the image with one being much brighter than the other. This illustrates some of the issues with measuring the amount of returning energy at different times of day and with changing flying heights. Flying the same area with any of these changes can yield different intensity values. Figure 30 illustrates a custom histogram to help balance the image to be more usable. The result can be seen in Figure 31. In order to correct for the two flight lines, the source data would have to be manipulated before the image is created.

**Figure 29 – Original intensity image with histogram stretch. This image also illustrates the two different flight lines on the right side of the image with different range of intensity values.**

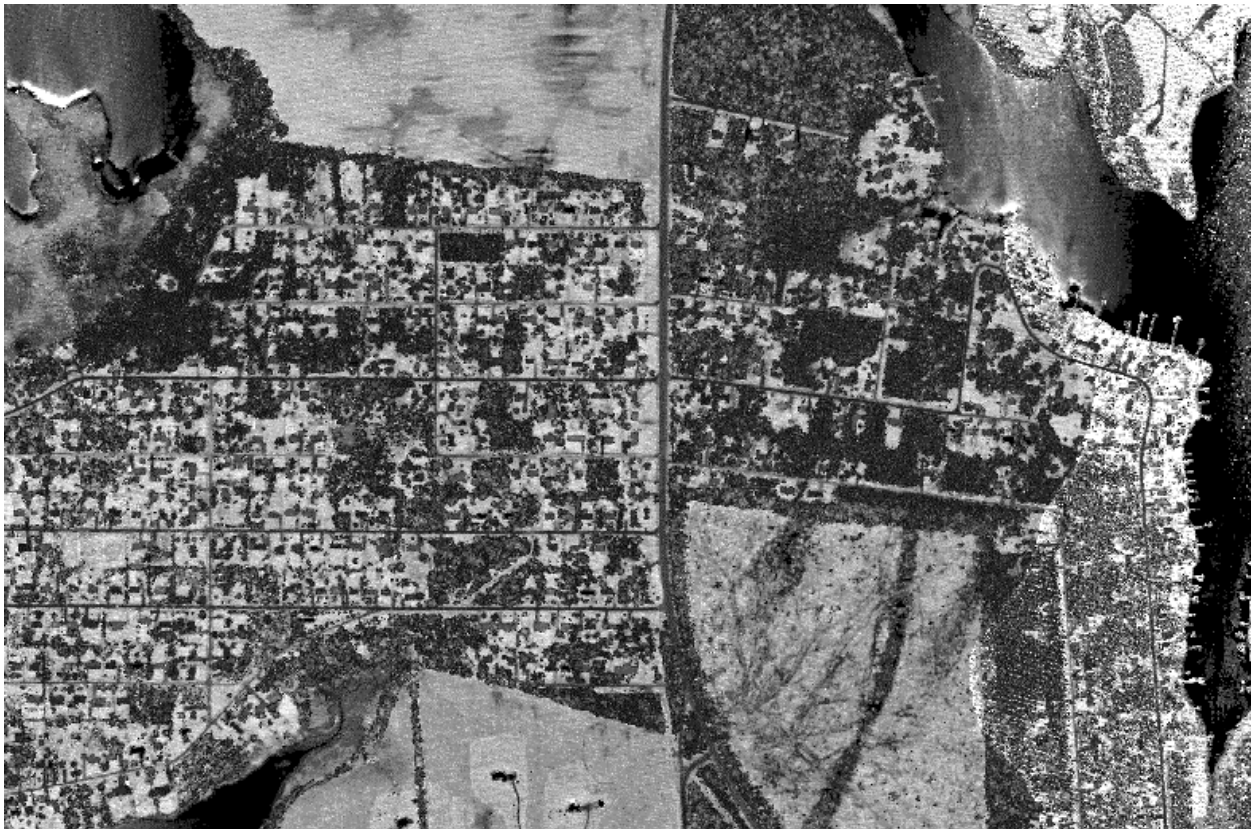
**Figure 31 – Intensity image after histogram manipulation. The image is now easier to see but still contains the two different flight lines on the right side of image.**

Dewberry recommends that the current process be improved to a higher level for any future work. The issue of the scan line edges and overlap were prevalent in some of the tiles tested. This error was usually within the 10 cm range. Two issues arise from this problem: first, the edges of the scan lines were slightly elevated, and second, they introduced a higher noise level of a few cm. This noise level will show a rougher surface. For most large projects this would not be a problem and can even currently be remedied by using the 2 meter grid. This in essence smoothes the surface and eliminates most of these minor anomalies. An additional recommendation is to replace those intensity images that were missing data.

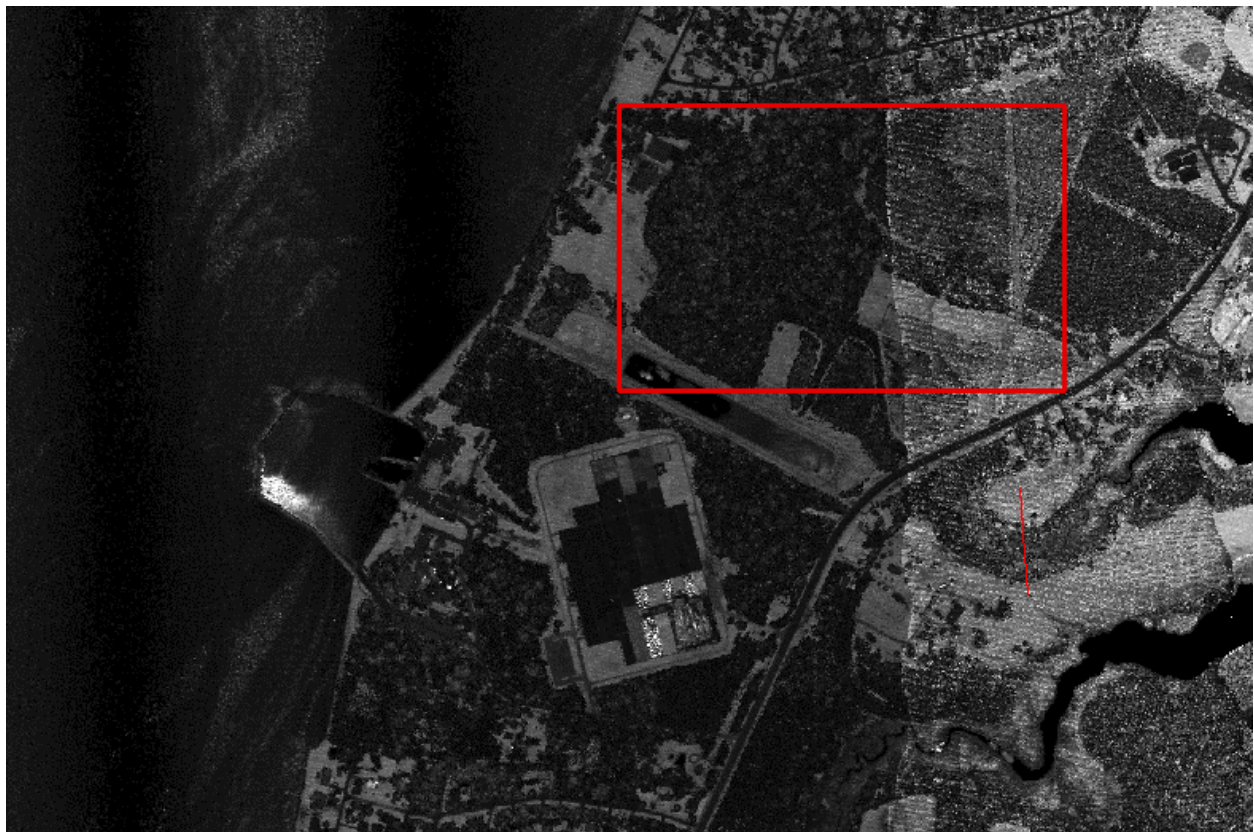
Figure 33 illustrates potential artifacts in the forested areas. These are minimal. Figure 34 and Figure 35 illustrate a problem that occurs a few times within this project in which there is a mismatch between scan lines. These differences between the scan lines can be caused by two main problems.

**Figure 35 – Area of mismatch between scan lines and area of artifacts.**
